Manhole Inspection Summary

Manhole # S35CC1005MH

Insp Date: **12/7/06 9:23 AM**

Location Address: **203 SOUTHWAY**

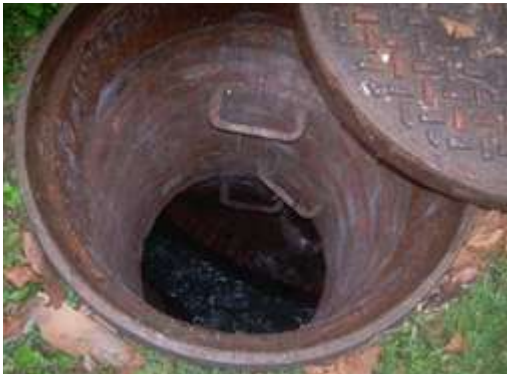
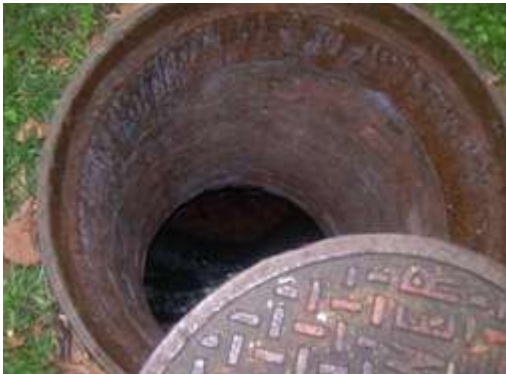
Defect

☒ **Leaks**

Condition: ☐ Sound ☐ Cracked ☐ Root Intrusion ☐ Loose Brick ☒ **Deteriorated**

Infiltration: ☐ None ☒ **Joint** ☐ Cracks ☐ Mortar ☐ Roots ☒ **Wall**

☒ **Evidence Of Surcharge**

Frame leaks. Adjustment deterioration and infiltration. Evidence of surcharge - Bench debris.

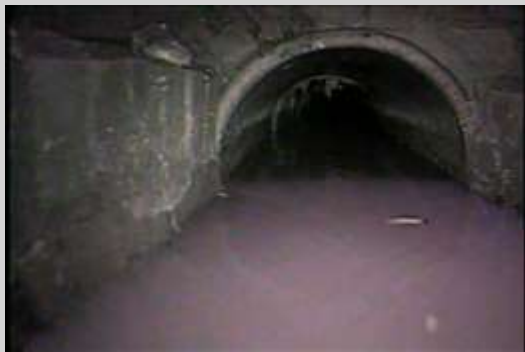
12 in. Circular Gravity Sewer Pipe Out @ 12 O'Clock

Infiltration: **Evidence** Pipe Seal Cond: **Cracked**
